ANNUAL REPORT FOR 2004

Marks Creek Stream Mitigation Site

Wake County

Prepared By:
Office of Natural Environment & Roadside Environmental Unit
North Carolina Department of Transportation
March 2005

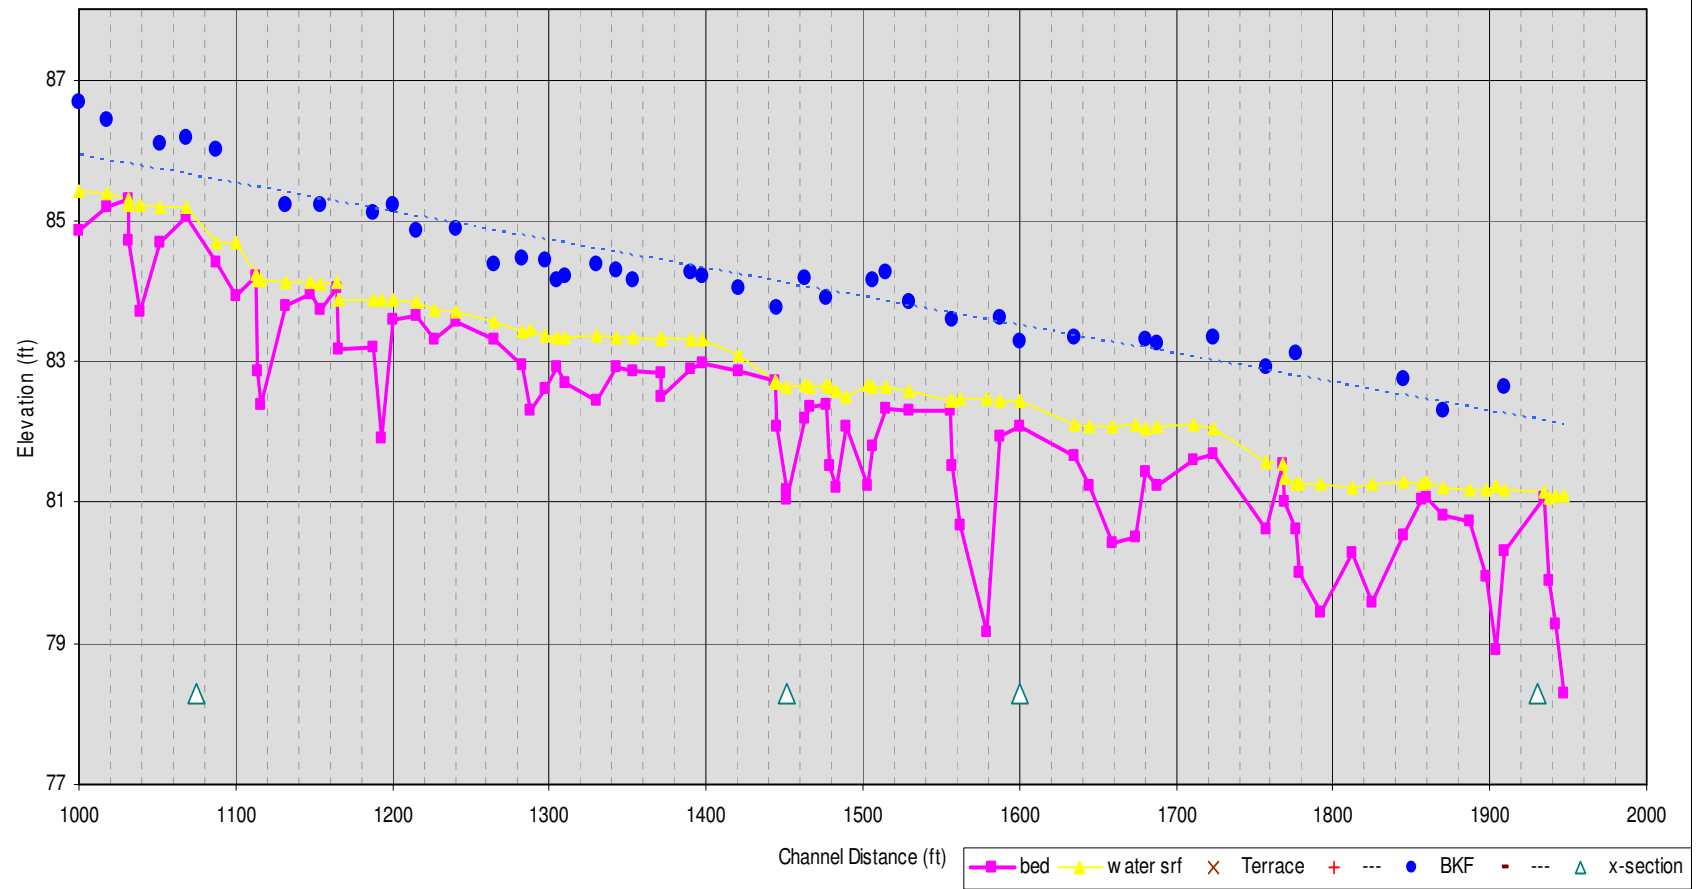
Longitudinal Profile of the Main Tributary, June 2004

- ◆ Station 13+00 through Station 13+10. A center bar was noted; however there was no indication of active erosion on the adjacent stream banks.
- ◆ Station 17+51 through Station 17+67. A transverse bar was observed in this area; however the adjacent stream banks appeared stable.

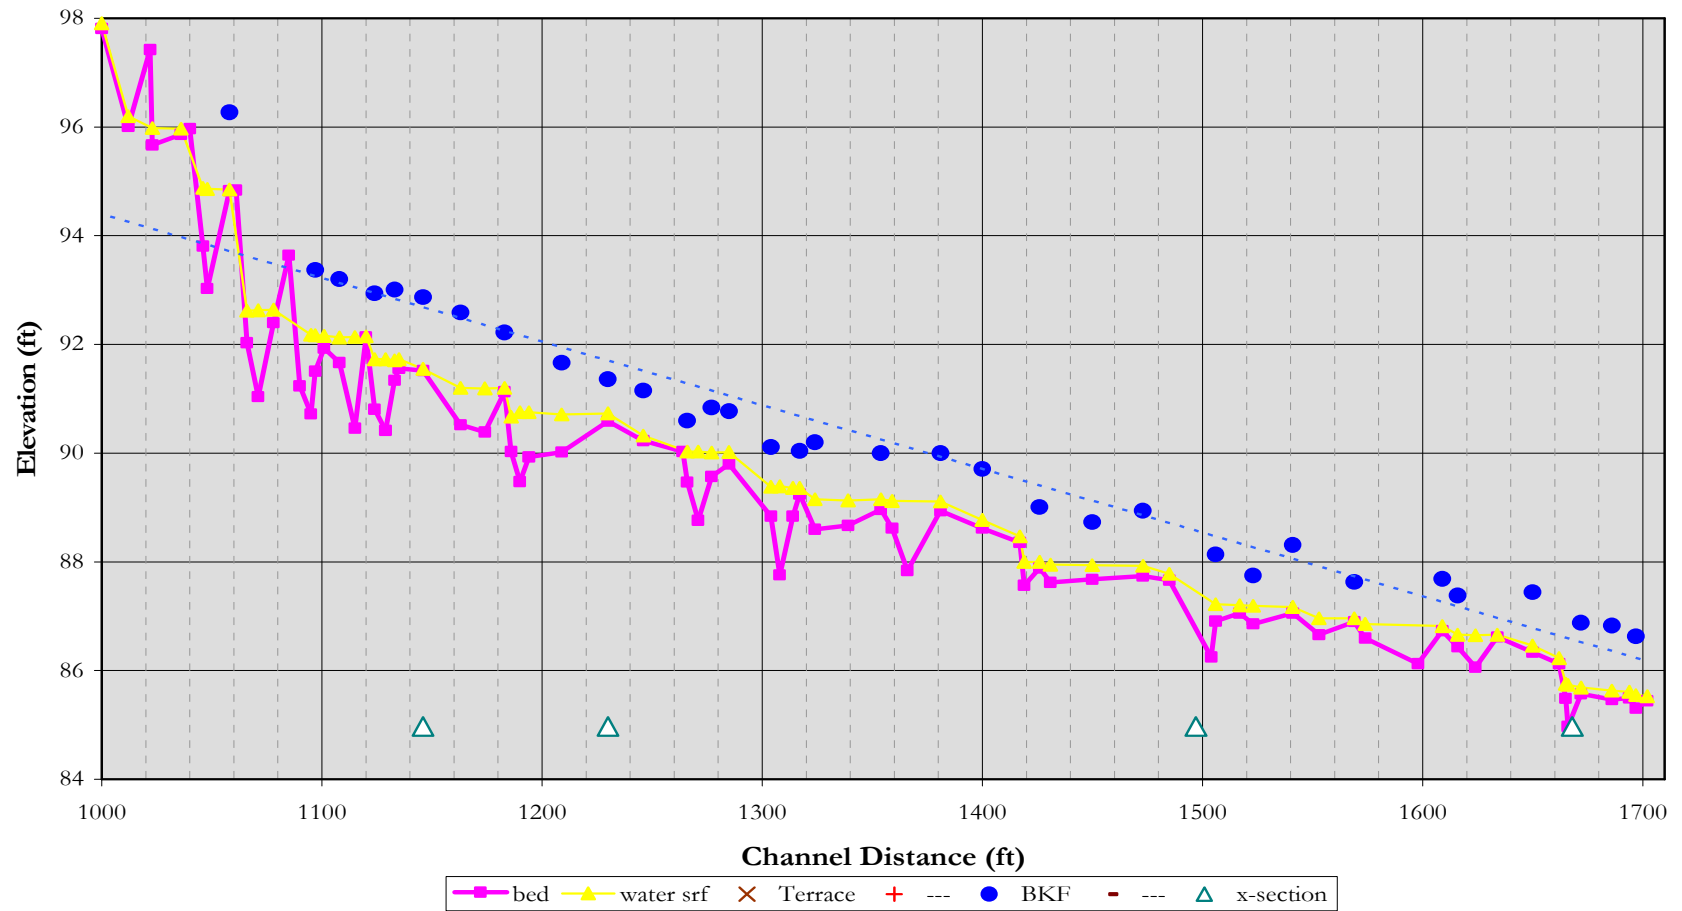
Longitudinal Profile of the North Tributary, June 2004

- ◆ Station 10+78 through Station 10+83. Active scouring along the right stream bank appears to have compromised the existing cross vane. This area will be re-assessed during the next monitoring period. No remedial actions are warranted at this time.

- ◆ Station 12+18 through Station 12+60. A center bar was observed; however the adjacent stream banks appeared stable with no active erosion.
- ◆ Station 13+66. A failing log vane has caused a back eddy to form and active erosion to take place along the adjacent stream banks. No remedial actions are required at this time; however this area will be re-assessed during the next monitoring period.

- ◆ Station 15+79 through Station 15+85. A center bar had developed in this area; however the adjacent stream banks appeared stable.
- ◆ Station 16+22 through Station 16+42. A center bar was noted; however there was no active erosion observed along the adjacent stream banks.

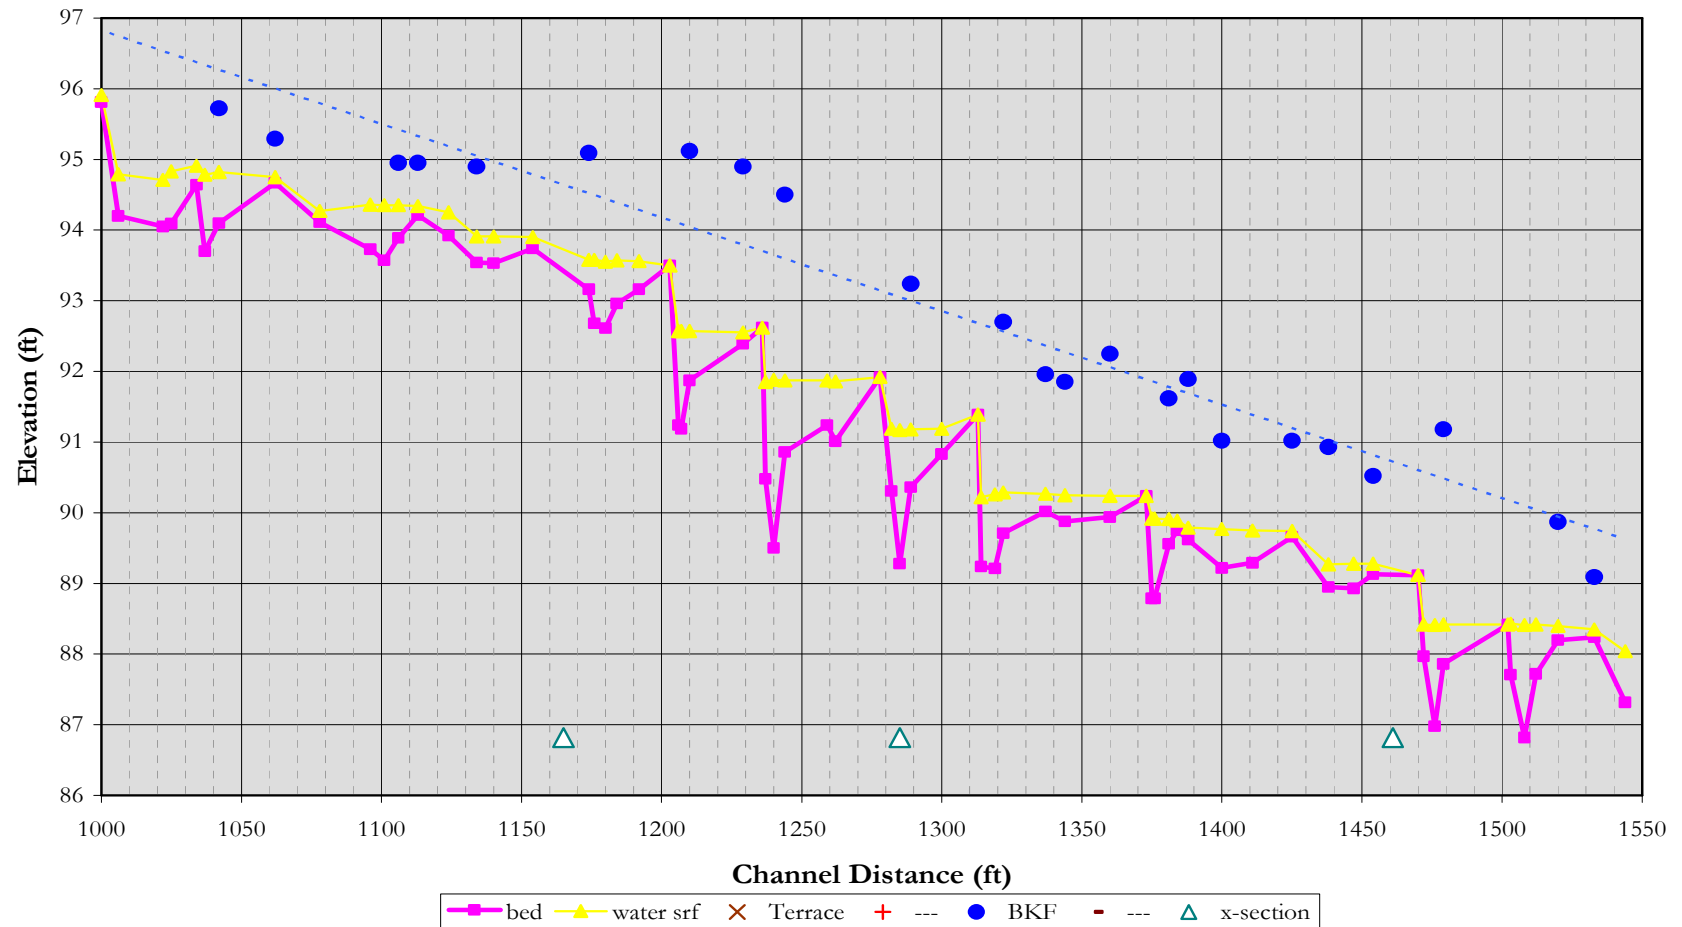
Longitudinal Profile of the West Tributary, June 2004

- ◆ Station 10+44 through Station 10+71. A center bar was observed in this area. The adjacent stream banks appeared stable with no active erosion.
- ◆ Station 11+15 through Station 11+35. A center bar has developed; however no active erosion was noted along the adjacent stream banks.

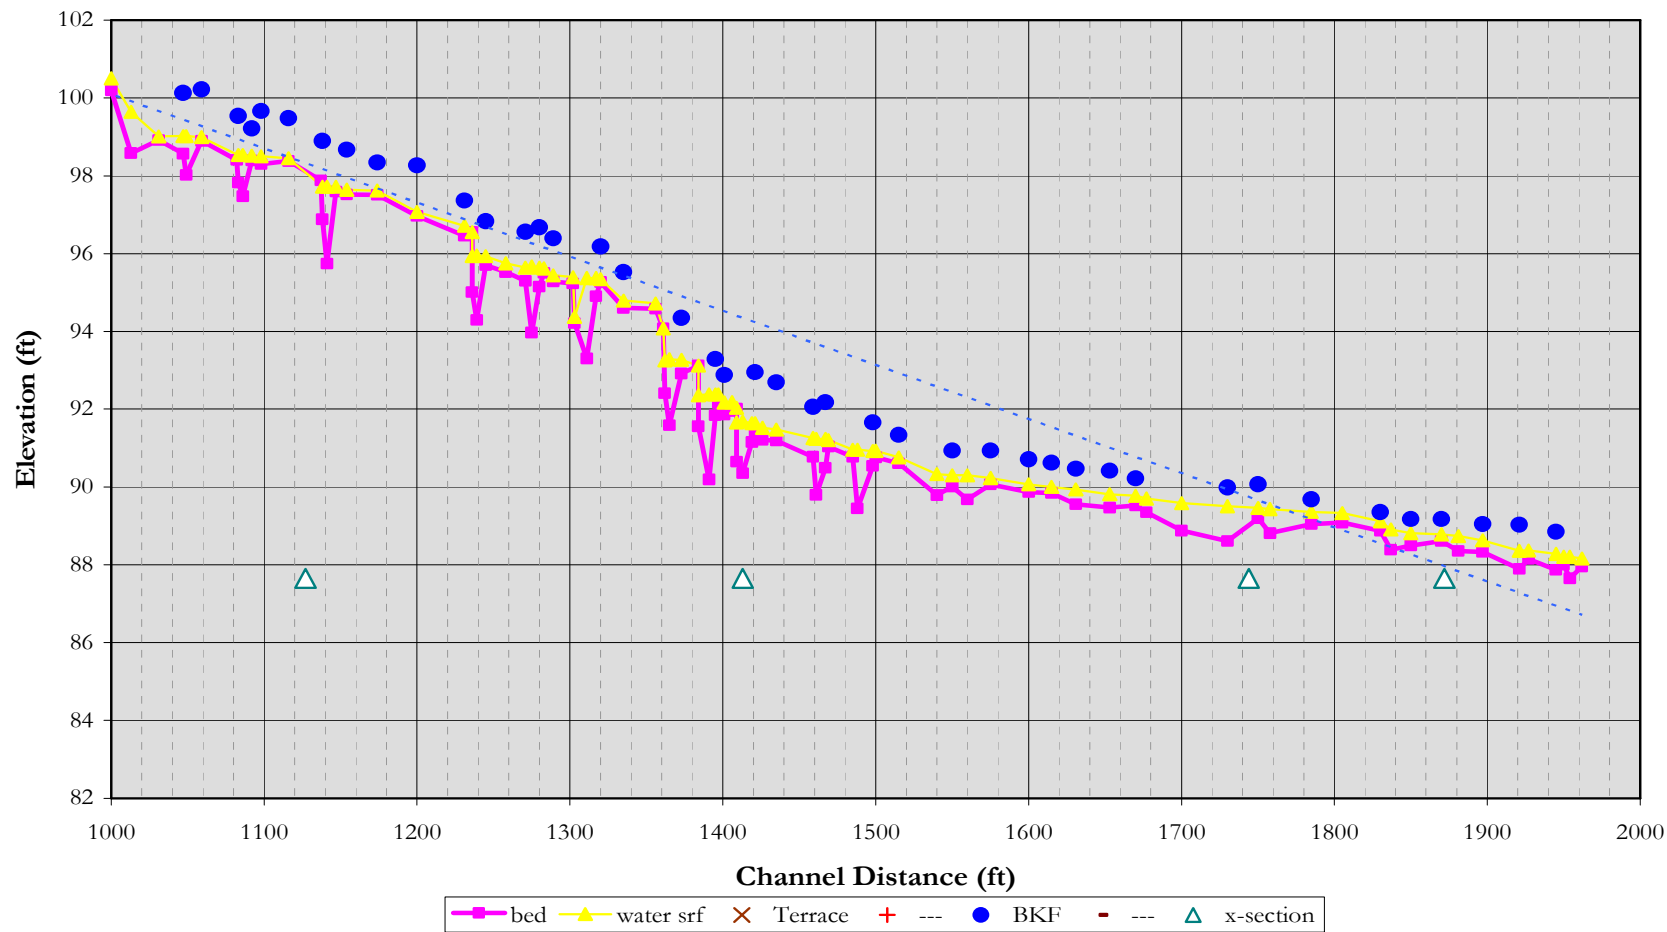
Longitudinal Profile of the South Tributary, June 2004

- ◆ Station 10+93 through 11+20. A center bar was noted in the stream channel; however no active erosion was noted along the adjacent stream banks.
- ◆ Station 11+48 through Station 11+54. An excessive amount of sediment has accumulated throughout this area. This area will be re-assessed during the next monitoring period. No remedial action is required at this time.

- ◆ Station 13+22 through 13+34. A center bar was observed throughout this area; however the adjacent stream banks appeared stable with no active erosion.

- ◆ Station 14+59 through 14+82. A center bar developed in this area; however no active erosion was observed along the adjacent stream banks.
- ◆ Station 14+20 through Station 19+70. The stream is heavily vegetated in this area. The channel has the possibility of aggrading throughout this area. A re-assessment of this area will take place during the next monitoring period. Remedial actions are not warranted.

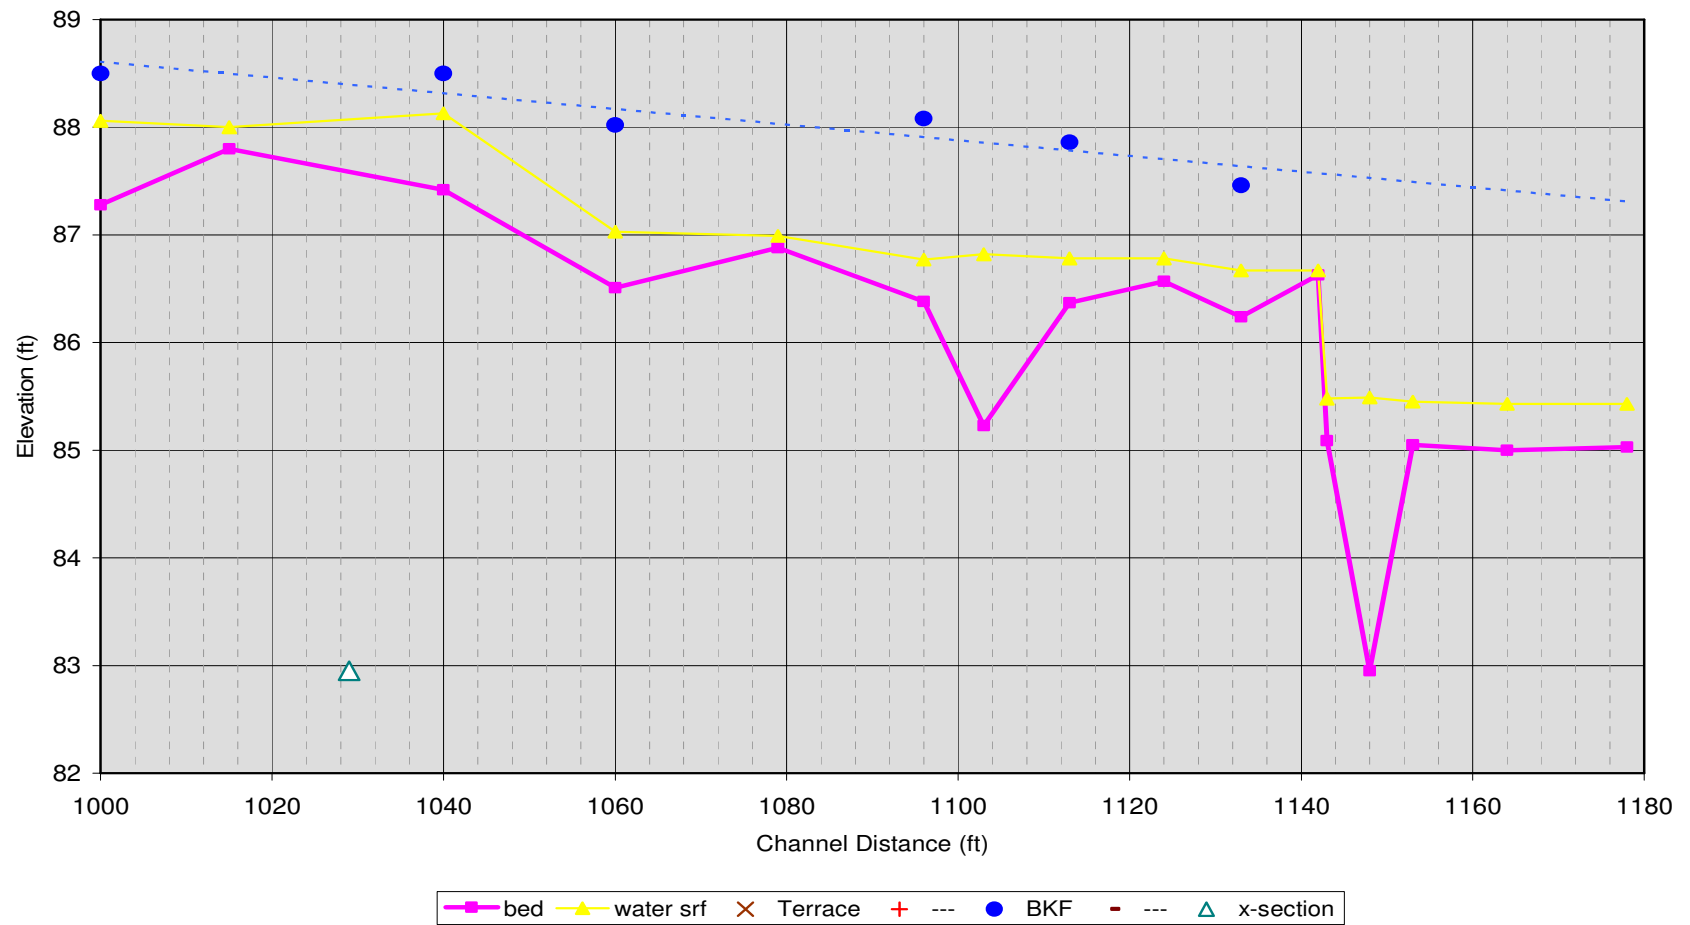
Longitudinal Profile of the Southwest Tributary, June 2004

- ◆ Station 11+20. A transverse bar was beginning to form in this area. The adjacent stream banks were stable with no indication of active erosion.

- ◆ Station 11+54 through 11+64. The heavy deposition throughout this area has caused the formation of two channels. This area will be re-assed during the next monitoring period. No remedial action is required at this time.
